PAPER NO.: 14

Investigations into Abrasive and Corrosive wear mechanisms of Pistons and Liners in large bore 2-stroke diesel engine cylinders

Terence McGeary, Flame Marine Ltd, United Kingdom
terence@flamemarine.com

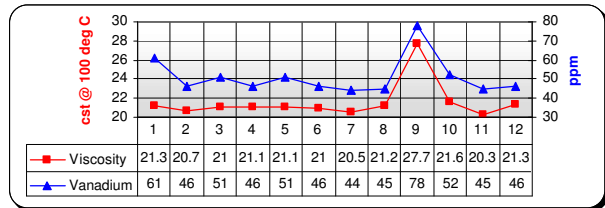
Chart 4 – Ship C (5th June 03 samples)

The high Vanadium and high Viscosity of Units 1 & 9 (Chart 4) indicate fuel contamination. And correspondingly high Iron for Units 1 & 9 seen in Chart 5 points to combustion irregularity causing higher wear.

High Viscosity and Vanadium for Unit 9 indicate fuel contamination

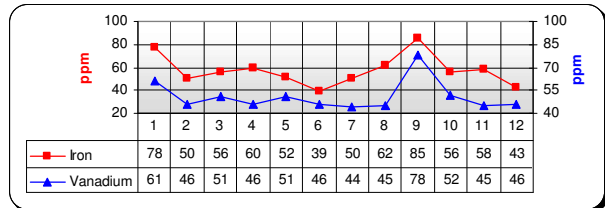
Chart 5 – Ship C (5th June 03 samples)

High Vanadium/ high Iron in Units 1 & 9 indicate that a combustion irregularity is causing an increase in wear.

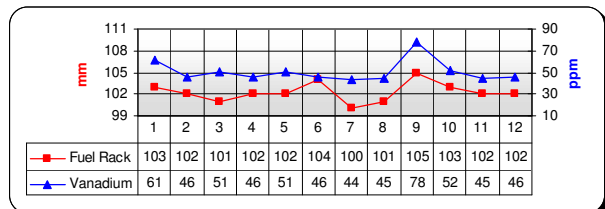
Chart 6 – Ship C (5th June 03 samples)

High Fuel Rack and Vanadium for Units 1 and 9 suggest greater amount of fuel injected

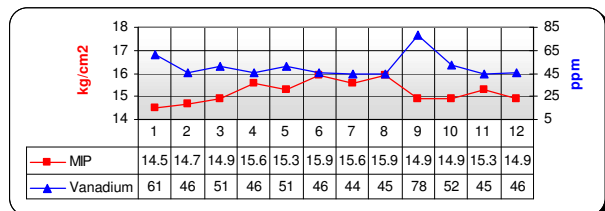
Chart 7 – Ship C (5th June 03 samples)

Chart 7 demonstrates how changes in the relationship between MIP and Vanadium can indicate even small changes in the efficiency of combustion. This assumes that the relationship between MIP and Vanadium should remain constant if the fuel injected burns completely, and that calorific value available in the fuel is effectively converted to heat energy. The MIP should then correspond with the amount of fuel injected.

A lower MIP, as compared with other cylinders with similar amount of fuel injected, would indicate, either that the fuel is not completely burned, due to defective atomisation, or the calorific value available in the fuel is not effectively converted to heat energy, due to incorrect timing or blow-by.

High Vanadium and low MIP in Units 1 and 9 indicate incomplete combustion

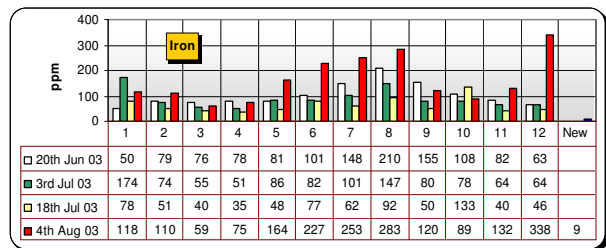
Chart 8 – Ship B (4th August 03 samples)

Although Iron in CDO data is being collected continuously and compared to that of liner wear calibrations the only inference drawn is that of variable wear mechanisms. Consequently no attempt is made by the authors to relate the two sets of data (CDO analysis and calibrated wear). The fluctuating and sporadic nature of wear of pistons rings and liners, combined with variations by associated fuel and system oil dilution, are likely to preclude even an empirical dependency. (Chart 8)

Fluctuation of Iron ppm between individual cylinders indicating wide variations in wear.

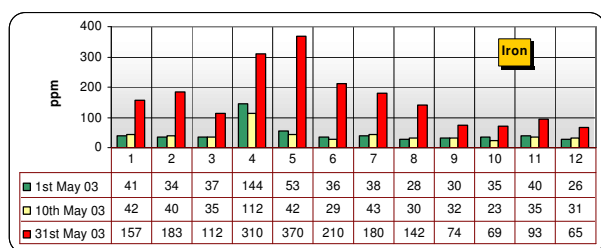
Chart 10 – Ship A (31st May 03 samples)

Variation in Iron between Units indicates that factors other than Sulphur are influencing wear.

Iron ppm is higher on the 31st May due to the higher Sulphur. However the large fluctuations in Iron ppm between individual units point to factors other than Sulphur causing the higher Iron in Units 1 to 8 & 11. Units 9, 10 & 12, being unaffected by “other factors”, demonstrate a small increase of about 40 ppm Iron as being caused by the higher Sulphur.

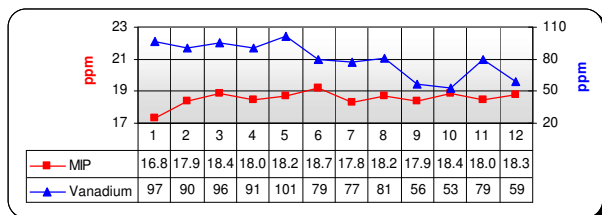
Chart 11 – Ship A (31st May 03 samples)

In Chart 11 the high Vanadium relative to the MIP for Units 1 – 8 & 11 infers incomplete combustion of a small part of the fuel injected, whereas in Units 9, 10 & 12 Vanadium is low in comparison with MIP.

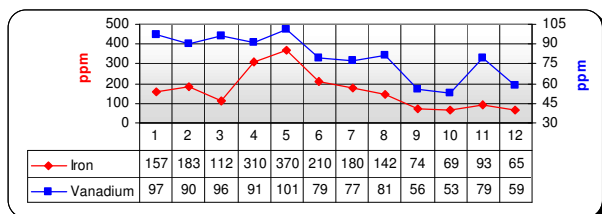
Chart 12 – Ship A (31st May 03 samples)

Chart 12 shows that higher Iron in Units 1 to 8 & 11 corresponds with higher Vanadium, which again indicates that incomplete combustion is influencing the Iron ppm. On the other hand Units 9, 10 and 12 have low Iron compared to Vanadium ppm.

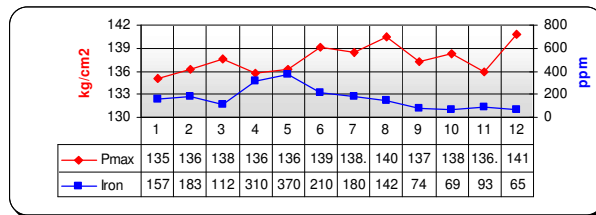
Chart 13 – Ship A (31st May 03 samples)

In Chart 13 a further, though weak, indicator is provided by Units 4 & 5 where the highest Iron values correspond with lower Pmax.

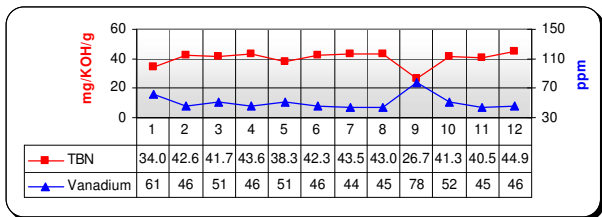
Chart 14 – Ship C (5th June 03 samples)

Chart 14 shows the effect of minor fuel contamination on TBN in Unit 1 and a greater amount of fuel contamination in Unit 9.

Contamination by fuel of the drain oil from Units 1 and 9 is diluting the TBN.

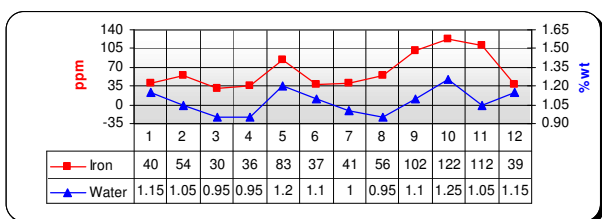
Chart 15– Ship C (8th September 03 samples)

Water is influencing Iron ppm particularly in Units 5 and 10.

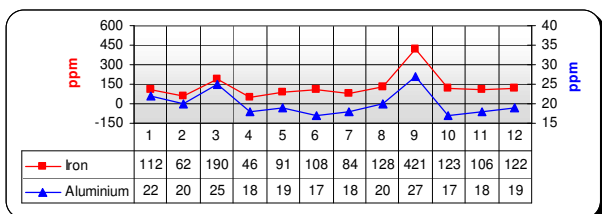
Chart 16 – Ship B (24th October 03 samples)

Cat-fines influencing Iron ppm particularly in Units 3 and 9.

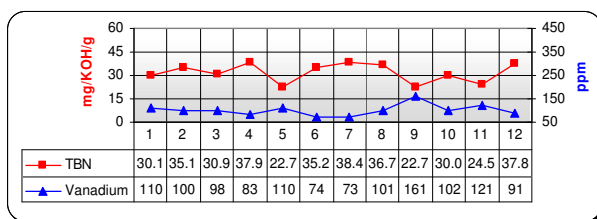
Chart 17 – Ship C (18th October 03 samples)

Dilution of the CDO by fuel contamination, or system oil leakage into the under-piston space, would give rise to a lower TBN value. Chart 17 shows that Fuel contamination is diluting the CDO in several cylinders of which Units 5, 9 and 11 are the most affected.

Fuel contamination diluting the TBN in Unit 9

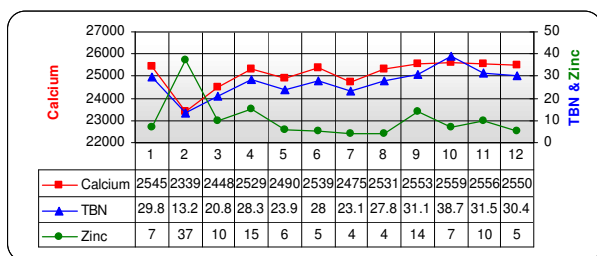
Chart 18 – Ship A (2nd October 03 samples)

Chart 18 demonstrates System oil (as indicated by Zinc) contaminating the cylinder drain oil from Unit 2 and diluting both TBN and Calcium. (Note that Calcium value of the fresh oil is 25,600 ppm)

System oil contamination diluting the TBN and Calcium in Unit 2

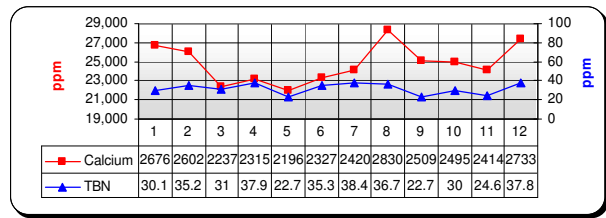
Chart 19 – Ship C (18th October 03 samples)

Chart 19 shows that cylinder lubricant is being burned in Units 1, 2, & 8 to 12 as indicated by the high Calcium relative to TBN.

High Calcium relative to TBN in Units 1, 2 & 8 to 12 indicates burning of cylinder lubricant

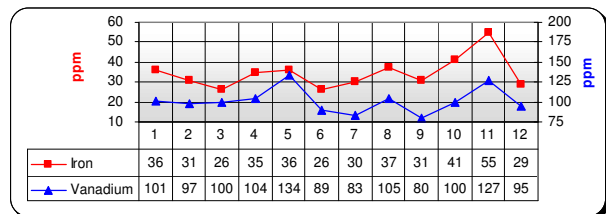
Chart 20 – Ship C (13th November 03 samples)

Minor changes in combustion conditions influencing wear

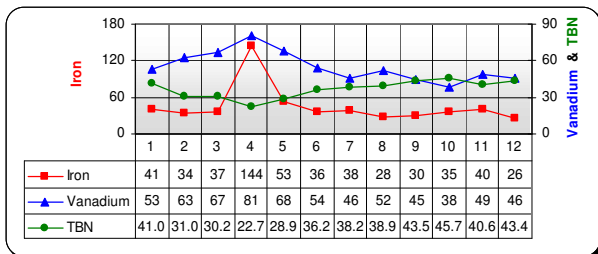
Chart 21 – Ship A (1st May 03 samples)

Unstable combustion in Unit 4 is causing increase in Iron ppm. Resultant Fuel contamination is diluting TBN.

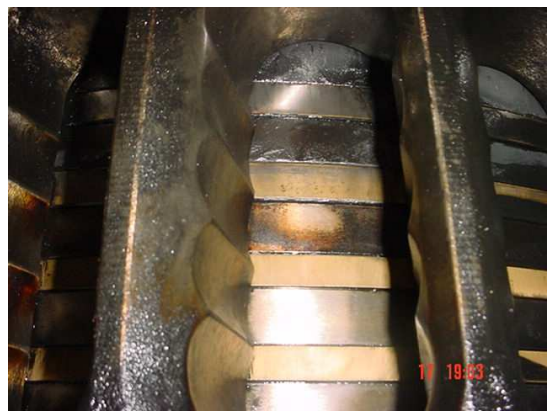
Pic 1 – Ship A (Inspection on 17th March 03)

Minor blow-by past 1st ring of Unit 4

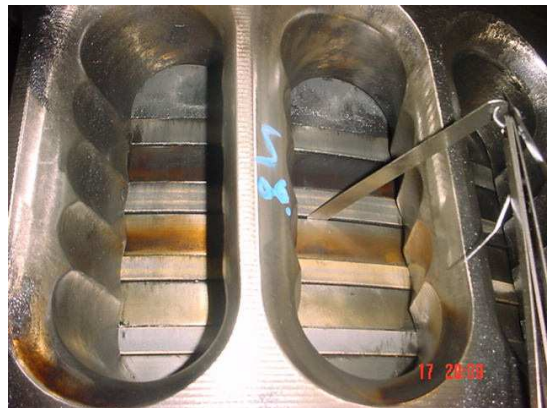
Pic 2 – Ship A (Inspection on 17th March 03)

Minor blow-by past 1st ring of Unit 5

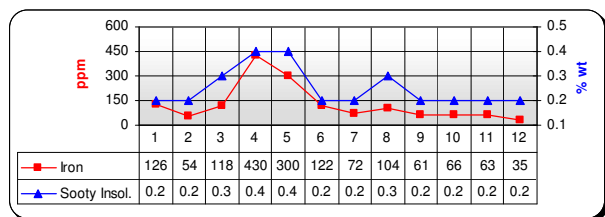
Chart 22 – Ship A (6th March 03 samples)

Minor blow-by on Units 4 and 5

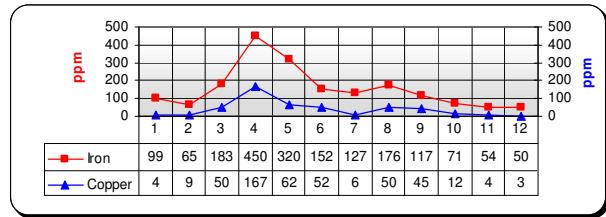
When wear does occur the high Iron in the CDO frequently corresponds with high Copper. This indicates abrasion between the piston skirt and liner wall as the piston beds in, and as the brass rubbing strip wears down. Chart 23 shows high Iron and Copper readings in Unit 4 at 151 hours following overhaul.

Unit 4 has high Iron and Copper during running-in.
Chart 23 – Ship A (7th February 03 samples)

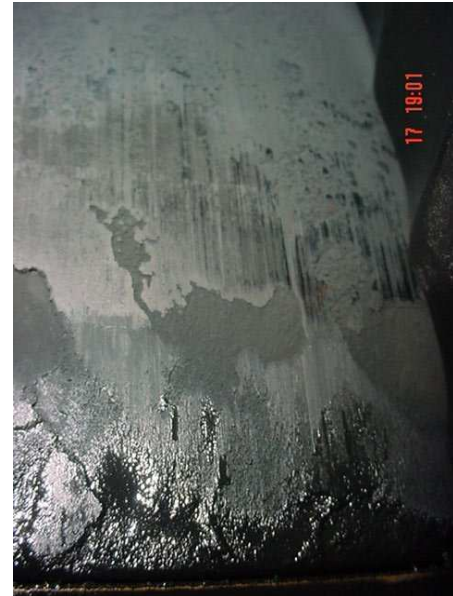
Deposits on Unit 4 piston top land abrading the liner wall.
Pic 3 – Ship A (Inspection on 17th March 03)

The authors of this current paper would add that the occurrence of deposit on the top land (Pic 3) tends to be linked also with abrasion between the piston skirt and the liner wall. The deposit build up on the piston topland appears to be restricting free movement of the piston, possibly affecting the normal alignment of the piston. In these circumstances there is a scraping action of the piston skirt (Pic 4) against the liner wall disrupting the lubricant film and causing abrasive wear. In the period during 2002 and 2003 the authors have noted frequent occurrences in both MAN B&W and Sulzer engine designs.

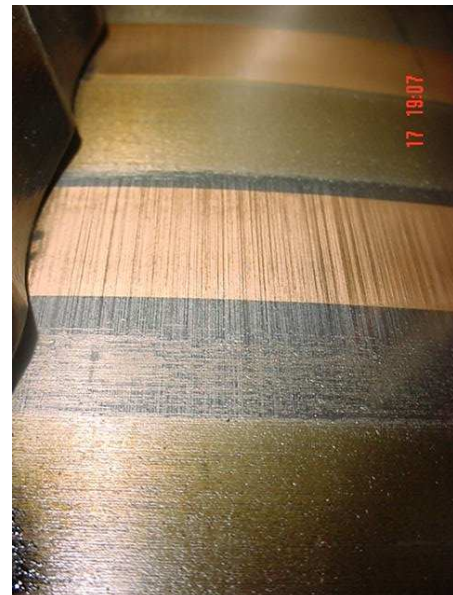
Initial wearing in of copper band on the piston skirt of Unit 4.
Pic 4 – Ship A (Inspection on 17th March 03)

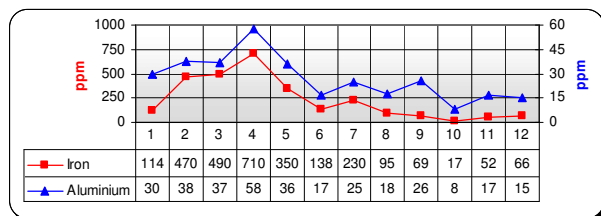
However, even Cat-fine content of 10 ppm Al "before ME Pump" as seen in the Fuel analysis in Chart 24, can cause abrasive wear. Chart 25 shows a close relationship between Iron and Aluminium when using the above Fuel, suggesting that Cat-fines are influencing wear in Units 1 to 7.

Cat-fines are influencing Iron ppm in Units 1 to 7.
Chart 25 – Ship A (18th February 03)

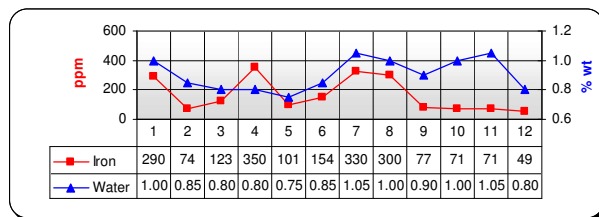
Water Influencing Iron in Units 1, 7 and 8
Chart 26 – Ship A (16th March 03 samples)

Chart 26 shows high Water influencing Iron in Units 1, 7 and 8. Similar high Water of 1.00 – 1.05% is not affecting Units 10 and 11. (The high Iron in Unit 4 is unrelated to Water, which is running-in following overhaul – see Chart 23.)
