PAPER NO.: 14

Investigations into Abrasive and Corrosive wear mechanisms of Pistons and Liners in large bore 2-stroke diesel engine cylinders

Terence McGeary, Flame Marine Ltd, United Kingdom
terence@flamemarine.com

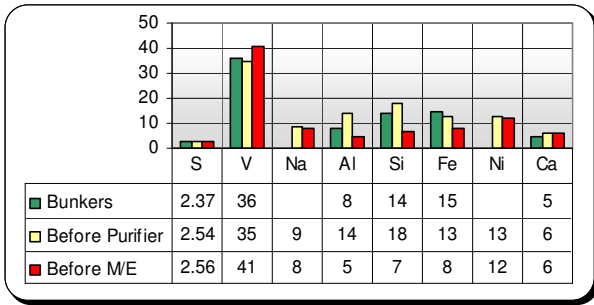
The three fuel analyses, “as Delivered”, “before Purifier” and “before ME pump” also showed variations in other characteristics of the fuel, indicating variations in Sulphur and Vanadium and other components. (Chart 1) The variations are explained by the fact that residual marine fuels are not homogeneous and that the analysis of fuel “as Delivered” is an average of the total quantity of fuel delivered. The fuel which is being injected into the combustion chamber is continuously changing. It was therefore important to have the Sulphur and Vanadium values for the fuel at the time that the cylinder oil drain samples were being drawn.

Fuel Analysis Comparison
Chart 1 – Ship A (6th July 03 samples)

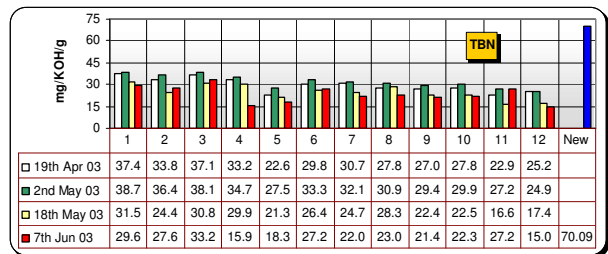
TBN trend
Chart 2 – Ship B – (7th June 03 samples)

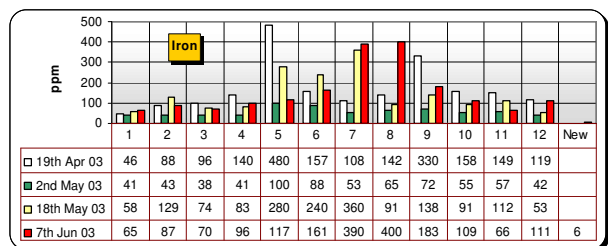
Iron Trend
Chart 3 – Ship B – (7th June 03 samples)

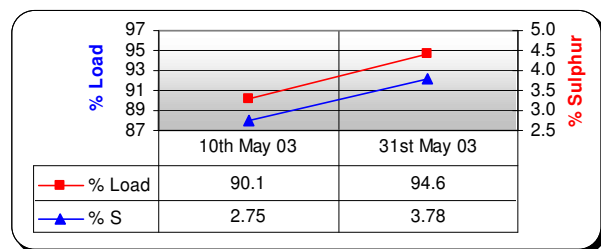
Chart 9 – Ship A (31st May 03 samples)

Fuel Sulphur & Engine Load are higher for 31st May 03 than Sulphur and Load on 10th May 03.

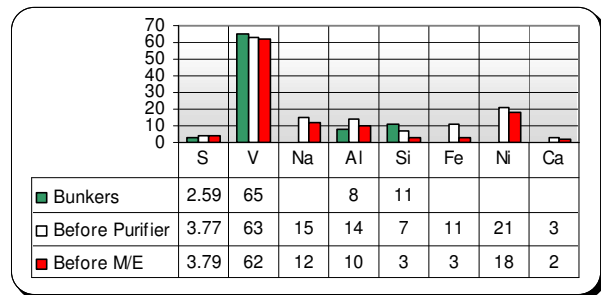
Fuel Analysis Comparison
Chart 24 – Ship A (18th February 03 samples)

However, even Cat-fine content of 10 ppm Al "before ME Pump" as seen in the Fuel analysis in Chart 24, can cause abrasive wear. Chart 25 shows a close relationship between Iron and Aluminium when using the above Fuel, suggesting that Cat-fines are influencing wear in Units 1 to 7.

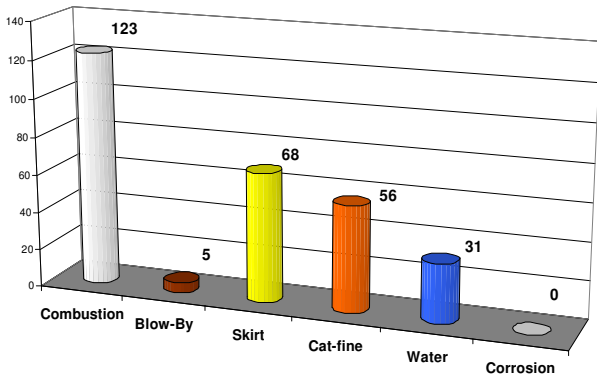
From a total of 672 CDO samples there were 283 samples showing increased wear.

Chart 27 – Incidences of wear by type of wear and by cylinder on all 3 ships from total 672 drain oil samples

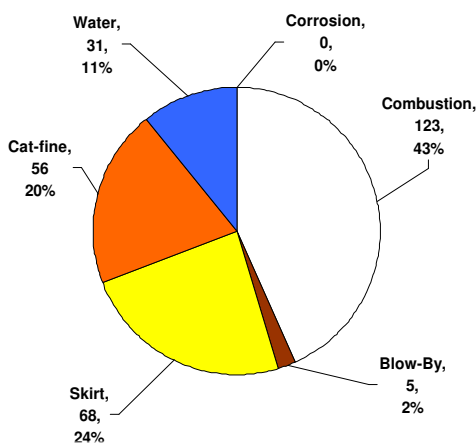
Chart 28 – Incidence of types of wear as percentage of the 283 samples which showed increased wear

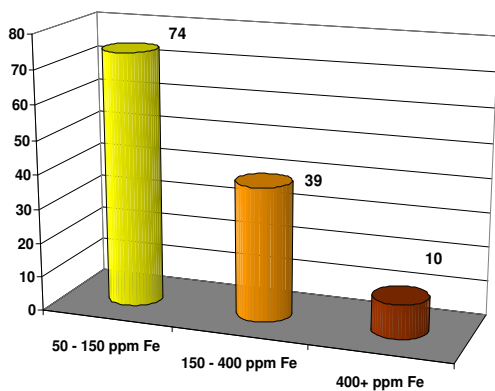
Number of Incidences of Combustion related wear, broken down into “normal”, “high” and “unusual”.

Chart 29 – Breakdown by degree of combustion related wear by cylinder for all 3 ships
