## **STUDY OF THE RELATIONSHIP BETWEEN CYLINDER LUBRICANT DRAIN CONDITION AND PERFORMANCE PARAMETERS OF 2-STROKE CROSS-HEAD ENGINES**

### **ABSTRACT**

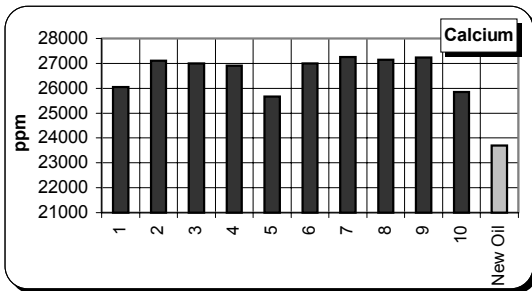
The Calcium values in **Fig 1** are higher than the 23,700 ppm found in the new oil, which indicates that the drain oil is carrying a lot of lubricant ash from lubricating oil that has been burned.

**Fig 1** - Calcium values from a MAN.B&W 10L80MC

The condition of over-lubrication can be seen in the condition of the drain oil by observing the TBN and Iron values. and, most significantly, when the Calcium value in the drain oil is higher than that in the new oil.

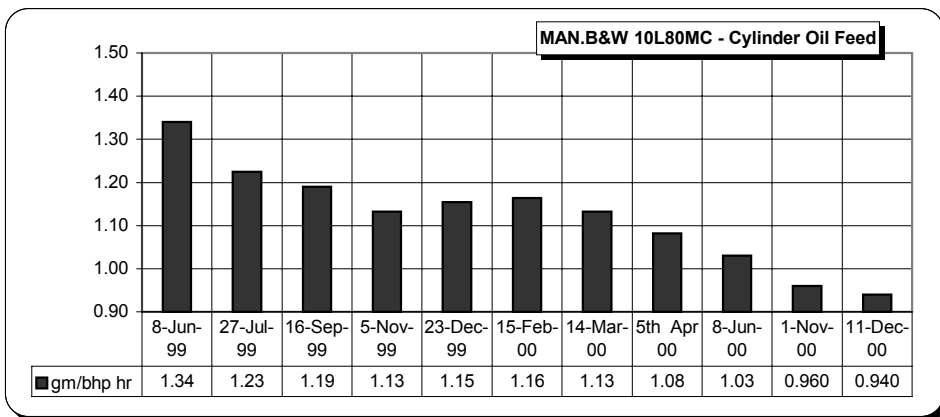
**Reduction of the feed rate** to a MAN.B&W 10L80MC engine was monitored<sup>(6)</sup> – **Fig 2** – under the guidance of the authors, and in agreement with engine manufacturer's recommendations, in steps of 0.067g/kWh (0.05g/bhp.hour). Three sets of drain oil samples were taken over a period of 2,000 hours before any reduction was made and then again, after each reduction, a further set of analyses is taken, before reducing by another step of 0.067gramme.

**Fig 2** – Progressive reduction of Cylinder Lubricant feed rates

The aim has been to reduce feed rates towards the lower level recommended by the Engine Manufacturers, as the results of the cylinder lubricant drain analyses confirm the possibility to do so.

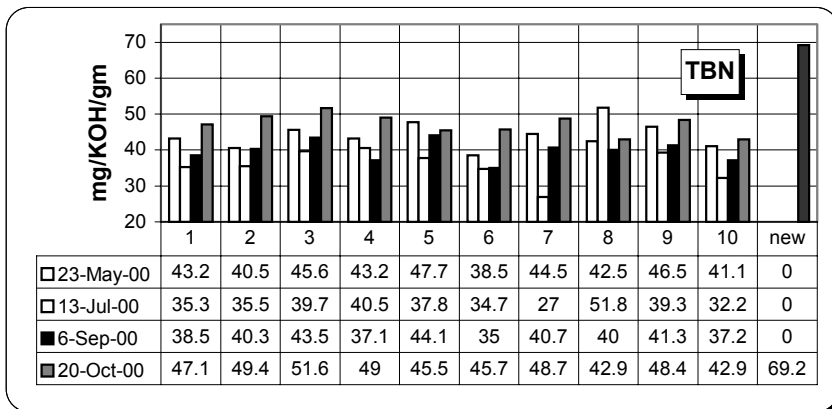
The relevant analysis values were monitored during the reduction process to ensure that all lubricant drain values were maintained within safe levels. See - **Figs 3 & 4**.

Fig 3 - TBN values during progressive reduction in Cylinder Lubricant Feed

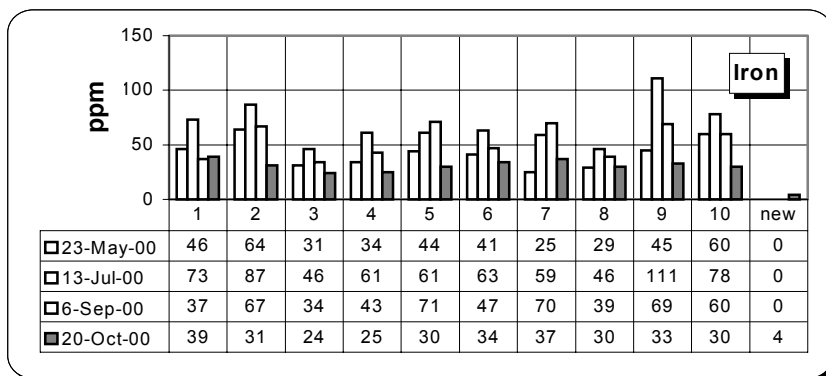
Fig 4 – Iron values during progressive reduction in Cylinder Lubricant Feed Rate

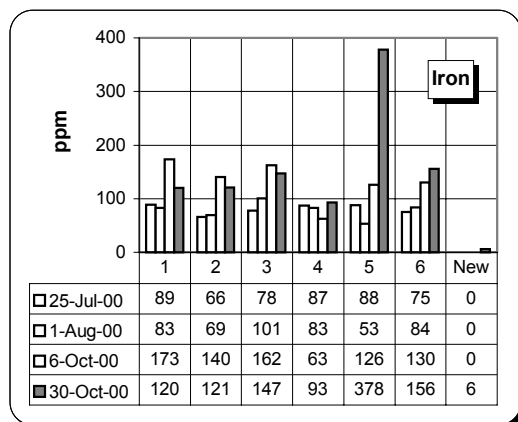
Tabulation of the Iron values in the drain oil, see Fig 5, from all engine cylinders permitted comparison of performance conditions between cylinder units.

Fig 5 – Iron values demonstrating sudden liner wear in No.5 Cylinder Unit

Plotting of Iron values for each engine cylinder from consecutive drain samples enabled the trends in liner wear to be evaluated. At overhaul intervals the wear trends noted by drain analysis were confirmed by physical measurements.

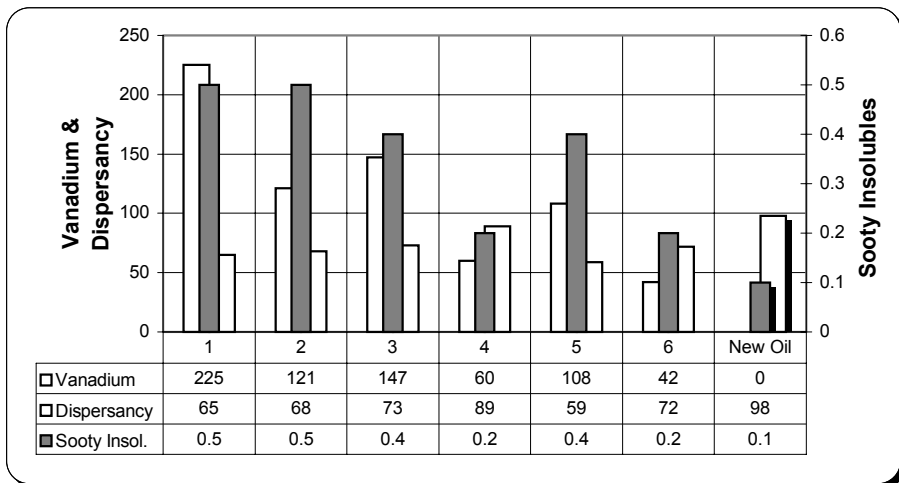
Fig 6 show analyses from an engine with poor combustion performance on one unit. There is good correlation between the analysis values

whereby poor combustion condition in Unit 1, indicated by high Vanadium, low Dispersancy and high Insolubles, contrasts with good combustion in Unit 4 having low vanadium, high Dispersancy and low Insolubles.

Fig 6 – Analysis values indicate poor combustion in Unit 1 and good combustion in Units 4 and 6.

By carrying out a comparison over several sets of samples taken at 1000 hour intervals, the trends, in terms of an improvement or deterioration in combustion conditions could be interpreted. When noting a deteriorating trend the operator can be alerted to the need for maintenance, be it the changing of an injector or the lifting of a piston with seized rings.

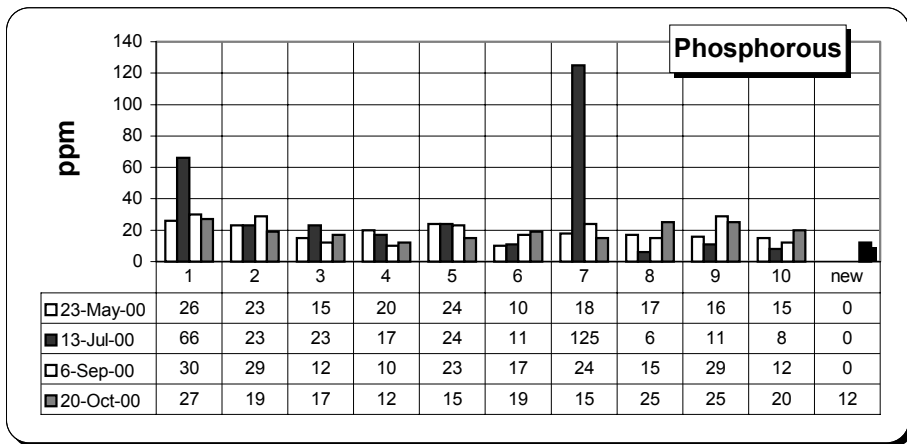
Analysis of Cylinder Lubricant drains from a MAN.B&W 10L80MC engine demonstrated incidence of an impending problem with piston rod of Unit 1 and a serious problem with Unit 7 as shown in Fig 7. Leakage of system oil from the crankcase upwards through the piston rod stuffing box was quickly noted and corrected.

Fig 7 – Sudden leakage of system oil at Units 1 & 7, detected and corrected

Leakage of system oil into the under-piston space is readily seen when analysing cylinder lubricant drain oil. The comparative performance of the piston rods of each unit can be noted from each unit sample, and the trend of leakage noted over a range of several samplings

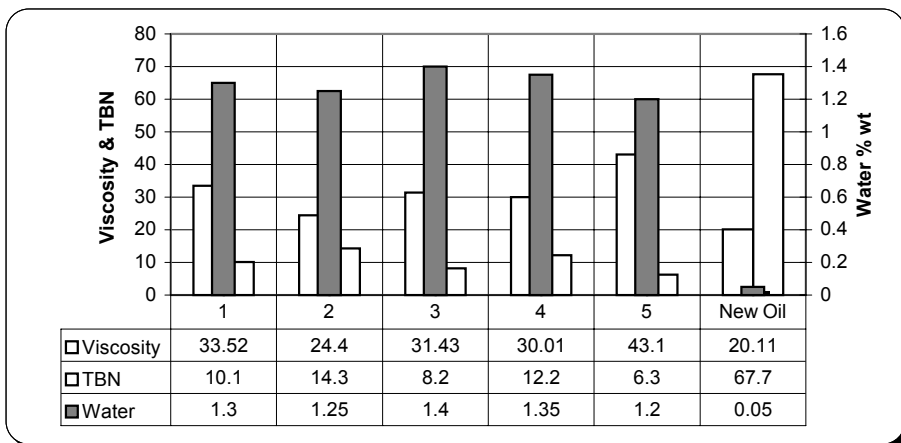
Fig – Effect of High water contamination in the Cylinder Lubricant

The presence of an excess of water in the diesel cylinder can have a detrimental effect on the ring and liner wear conditions<sup>(3)</sup> as was demonstrated in the analyses from a Sulzer 5RTA72 engine – Fig 8.

Water is reported<sup>(3)</sup> to cause an increase in the formation of acid and an increase in liner wear. The authors have observed that water contamination is accompanied by an increase in viscosity, probably due to emulsification of the cylinder oil, and also by a marked drop in the alkalinity and increase in Iron values. Although the mechanism is not clear to the authors by which the lubricant, and the lubrication process, breaks down, it is understood that the water may cause an increase in the formation of a dilute and highly corrosive acid, and a breakdown in the alkaline component of the cylinder lubricant, reducing its effectiveness in neutralising acid formation.

Study of the parameters allowed recommendation of prompt remedial action to the operator before the problem of water contamination developed. An alert to the possible source of the water can be indicated, as, in this case, a blocked water separator drain, or be it exceptional ambient humidity, and correction before excessive wear took place.
